**Flood Control Project Maintenance
Levee Inspections**
LMA District Cover Sheet
Spring 2014 Levee Inspection Results

San Joaquin County Flood Control and Water Conservation District

Spring 2014 Levee Inspection Results

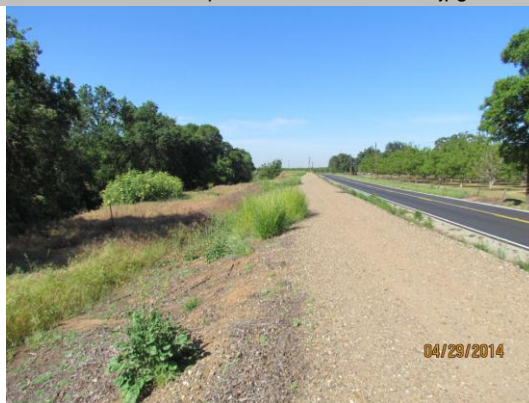
Photo 1 of 1 : pkazi_s_20140502_933.jpg

LM Start	0.66	Rating **	M	Issue No.	22
LM End	3.07	Issue Type +	Ma	Location *	WS
Category	Earthen Levee			GPS Latitude/Longitude	
				Start	End
Item	Vegetation			38.046884 °	38.026892 °
				-121.020853 °	-121.053947 °
DWR ID	DWR_NA0017_15_s_2014_22				
Action/Comments					
Control annual grass and weeds on the levee slopes and easements.

Vegetation on the waterside of the levee looking downstream.

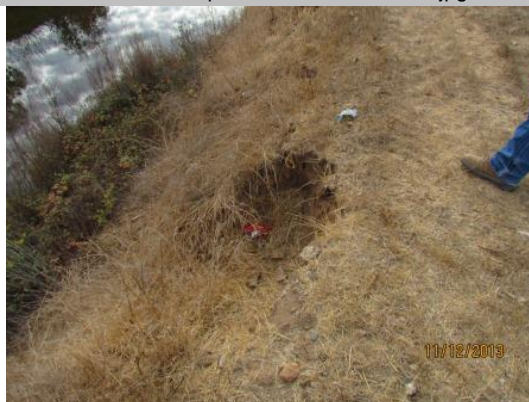
Photo 1 of 1 : pkazi_s_20140415_339.jpg

LM Start	0.87	Rating **	M	Issue No.	4
LM End	0.87	Issue Type +	Ma	Location *	WS
Category	Earthen Levee			GPS Latitude/Longitude	
				Start	End
Item	Slope Stability			38.045390 °	38.045390 °
				-121.024111 °	-121.024111 °
DWR ID	DWR_NA0017_15_f_2013_4				
Action/Comments					
Repair slope instability.

Slope instability was found on the waterside slope of the levee looking downstream.

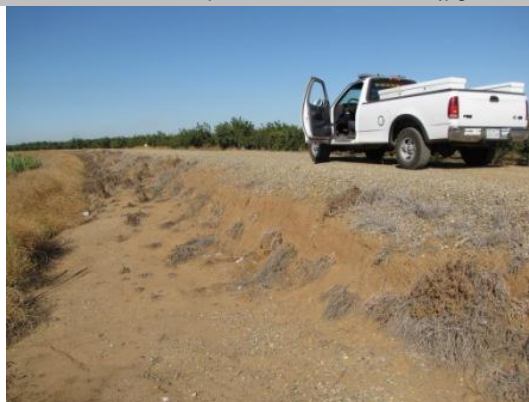
Photo 1 of 1 : pkazi_s_20140415_455.jpg

LM Start	1.52	Rating **	M	Issue No.	995
LM End	1.52	Issue Type +	Ma	Location *	WS
Category	Earthen Levee			GPS Latitude/Longitude	
				Start	End
Item	Erosion / Bank Caving			38.040202 °	38.040202 °
				-121.032659 °	-121.032659 °
DWR ID	DWR_NA0017_15_s_2012_995				
Action/Comments					
Schedule repair of erosion site prior to the next inspection. Inspector Comments: The LMA was working on fixing the erosion site using an excavator during the inspection.

View of erosion of waterward levee slope looking upstream.

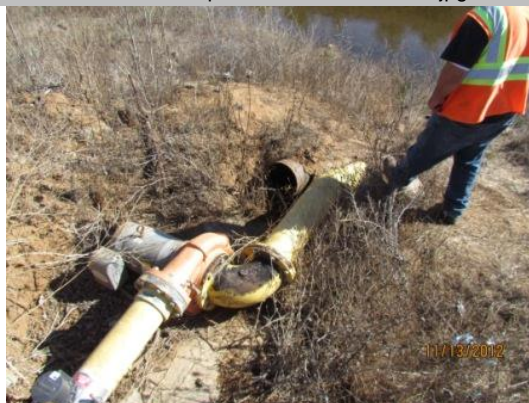
Photo 1 of 1 : pkazi_s_20140415_340.jpg

LM Start	2.09	Rating **	M	Issue No.	5
LM End	2.09	Issue Type +	En	Location *	WS
Category	Earthen Levee			GPS Latitude/Longitude	
				Start	End
Item	Encroachments			38.036299 °	38.036299 °
				-121.041091 °	-121.041091 °
DWR ID	DWR_NA0017_15_f_2012_5				
Action/Comments					
Pipe Inspector Comments: Abandon pipe on the waterside toe of the levee.

View of an open abandoned pipe at the waterside toe of the levee looking upstream.

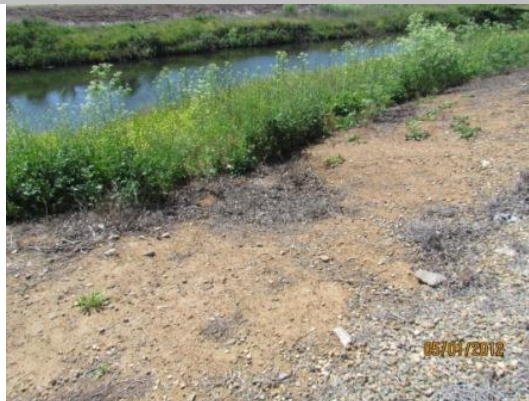
Photo 1 of 2 : pkazi_s_20140415_348.jpg

LM Start	2.09	Rating **	M	Issue No.	18
LM End	2.09	Issue Type +	Ma	Location *	WS
Category	Earthen Levee			GPS Latitude/Longitude	
				Start	End
Item	Slope Stability			38.036294 °	38.036294 °
				-121.041089 °	-121.041089 °
DWR ID	DWR_NA0017_15_s_2012_18				
Action/Comments					
Repair slope instability.

Slope instability was found on the waterside toe of the levee looking downstream.

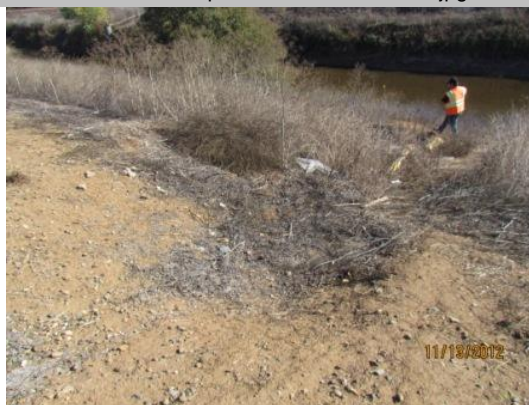
Photo 2 of 2 : pkazi_s_20140415_349.jpg

LM Start	2.09	Rating **	M	Issue No.	18 (cont)
LM End	2.09	Issue Type +	Ma	Location *	WS

Updated picture of the slope instability at the waterside slope of the levee looking upstream.

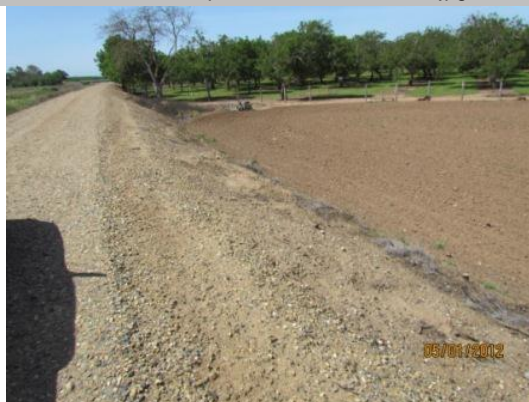
Photo 1 of 1 : pkazi_s_20140415_379.jpg

LM Start	2.59	Rating **	M	Issue No.	47
LM End	2.59	Issue Type +	Ma	Location *	LS
Category	Earthen Levee			GPS Latitude/Longitude	
				Start	End
Item	Slope Stability			38.031234 °	38.031234 °
				-121.047254 °	-121.047254 °
DWR ID	DWR_NA0017_15_s_2012_47				
Action/Comments					
Repair slope instability.

Slope instability was found on the landside slope of the levee looking downstream.

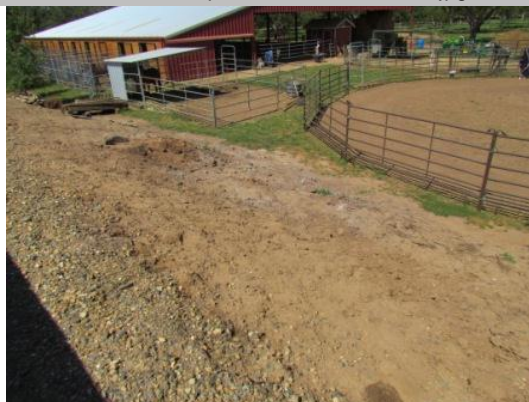
Photo 1 of 1 : pkazi_s_20140415_358.jpg

LM Start	2.68	Rating **	M	Issue No.	27
LM End	2.68	Issue Type +	Ma	Location *	LS
Category	Earthen Levee			GPS Latitude/Longitude	
				Start	End
Item	Slope Stability			38.030252 °	38.030252 °
				-121.048311 °	-121.048311 °
DWR ID	DWR_NA0017_15_s_2012_27				
Action/Comments					
Repair slope instability.

Slope instability was found on the landside of the levee. The picture was taken from the crown looking downstream.

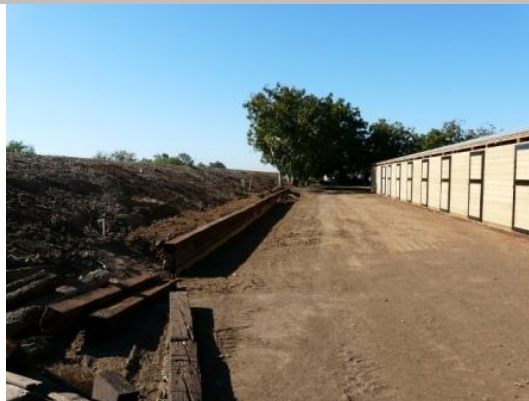
Photo 1 of 2 : pkazi_s_20140415_391.jpg

LM Start	2.68	Rating **	M	Issue No.	66
LM End	2.71	Issue Type +	En	Location *	LS
Category	Earthen Levee			GPS Latitude/Longitude	
				Start	End
Item	Encroachments			38.030173 °	38.029949 °
				-121.048432 °	-121.048732 °
DWR ID	DWR_NA0017_15_s_2012_66				
Action/Comments					
Building Inspector Comments: Retaining wall at toe of slope & irrigation recently placed.

Recently built retaining wall at toe of landside levee at LM 2.68.

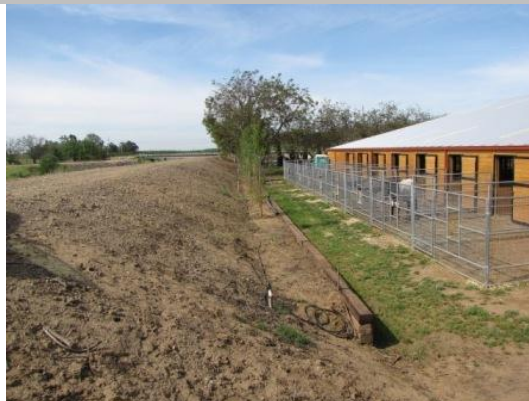
Photo 2 of 2 : pkazi_s_20140415_392.jpg

LM Start	2.68	Rating **	M	Issue No.	66 (cont)
LM End	2.71	Issue Type +	En	Location *	LS
Category	Earthen Levee			GPS Latitude/Longitude	
				Start	End
Item	Encroachments			38.030173 °	38.029949 °
				-121.048432 °	-121.048732 °
DWR ID	DWR_NA0017_15_s _ 2012_66				
Action/Comments					
Building Inspector Comments: Retaining wall at toe of slope & irrigation recently placed.

Updated view as of spring 2009. Landscaping and irrigation have been added at the toe of the levee.

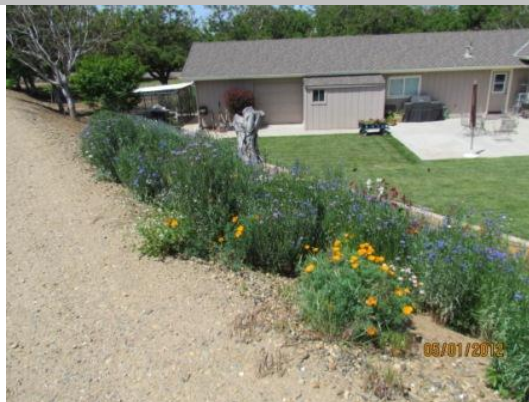
Photo 1 of 1 : pkazi_s_20140415_338.jpg

LM Start	2.73	Rating **	M	Issue No.	3
LM End	2.73	Issue Type +	En	Location *	LS
Category	Earthen Levee			GPS Latitude/Longitude	
				Start	End
Item	Vegetation			38.030185 °	38.030185 °
				-121.049397 °	-121.049397 °
DWR ID	DWR_NA0017_15_s _ 2012_3				
Action/Comments					
Landscaping

Landscape was found on the landside of the levee looking downstream.

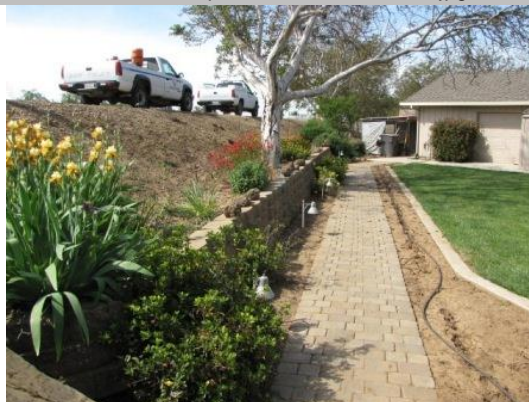
Photo 1 of 1 : pkazi_s_20140415_452.jpg

LM Start	2.74	Rating **	M	Issue No.	959
LM End	2.75	Issue Type +	En	Location *	LS
Category	Earthen Levee			GPS Latitude/Longitude	
				Start	End
Item	Encroachments			38.029641 °	38.029505 °
				-121.049165 °	-121.049372 °
DWR ID	DWR_NA0017_15_s _ 2012_959				
Action/Comments					
Building Inspector Comments: Retaining wall at landside toe of levee.

View of retaining wall and landscaping along the landward toe of the levee.

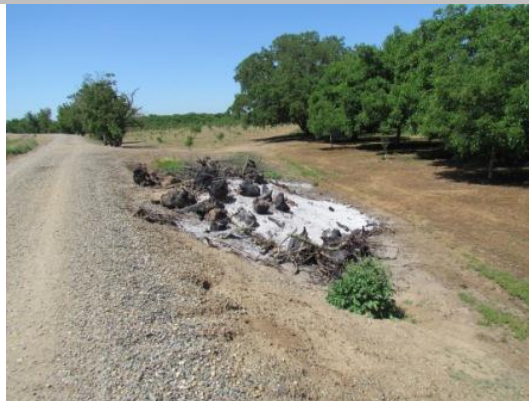
Photo 1 of 1 : pkazi_s_20140415_344.jpg

LM Start	3.40	Rating **	M	Issue No.	12
LM End	3.40	Issue Type +	Ma	Location *	LS
Category	Earthen Levee			GPS Latitude/Longitude	
				Start	End
Item	Encroachments			38.023817 °	38.023817 °
				-121.058465 °	-121.058465 °
DWR ID	DWR_NA0017_15_s _ 2012_12				
Action/Comments					
Prunings					
Inspector Comments: Burn pile has been burned but new material has been placed.

Burn pile and new material was placed at the toe of the landside of the levee. The picture was taken from the crown looking downstream.

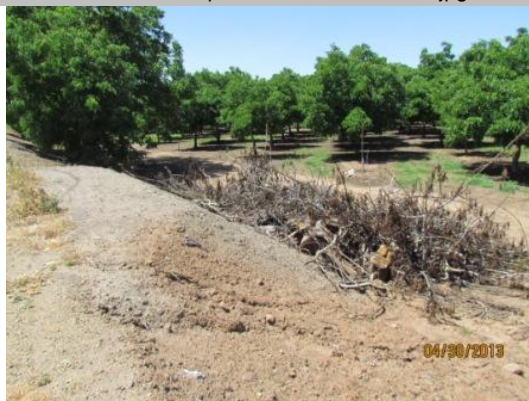
Photo 1 of 1 : pkazi_s_20140415_345.jpg

LM Start	3.61	Rating **	A/W	Issue No.	14
LM End	3.61	Issue Type +	Ma	Location *	LS
Category	Earthen Levee			GPS Latitude/Longitude	
				Start	End
Item	Encroachments			38.021811 °	38.021811 °
				-121.061054 °	-121.061054 °
DWR ID	DWR_NA0017_15_s _ 2013_14				
Action/Comments					
Prunings					
Inspector Comments: The pit was repaired by the LMA but the pruning still exists. The burn pile is away from the levee prism.

Prunings were found on the landside toe of the levee looking downstream.

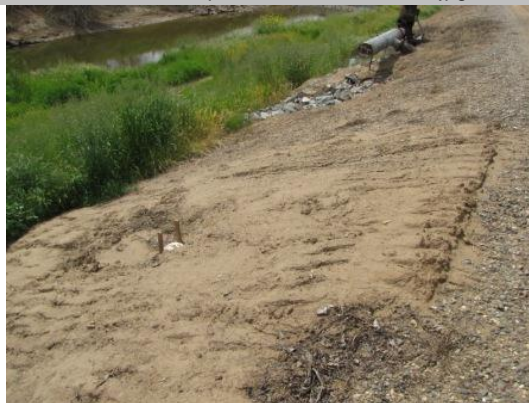
Photo 1 of 1 : pkazi_s_20140415_382.jpg

LM Start	3.62	Rating **	M	Issue No.	54
LM End	3.62	Issue Type +	Ma	Location *	WS
Category	Earthen Levee			GPS Latitude/Longitude	
				Start	End
Item	Encroachments			38.021601 °	38.021601 °
				-121.061284 °	-121.061284 °
DWR ID	DWR_NA0017_15_s_2012_54				
Action/Comments					
Pipe Inspector Comments: A recently placed pipe in the waterward slope may be leaking and was not authorized.

View of a recently placed pipe in the waterward slope looking downstream.

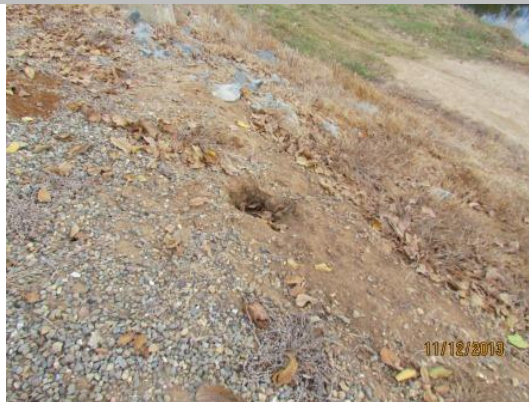
Photo 1 of 1 : pkazi_s_20140415_347.jpg

An animal hole was found on the waterside slope of the levee looking upstream.

LM Start	3.64	Rating **	M	Issue No.	17
LM End	3.64	Issue Type +	Ma	Location *	WS
Category	Earthen Levee			GPS Latitude/Longitude	
				Start	End
Item	Animal Control			38.021468 °	38.021468 °
				-121.061442 °	-121.061442 °
DWR ID	DWR_NA0017_15_f_2013_17				
Action/Comments					
No rodents visible, but rodent burrows visible; need to backfill and compact or grout burrows.

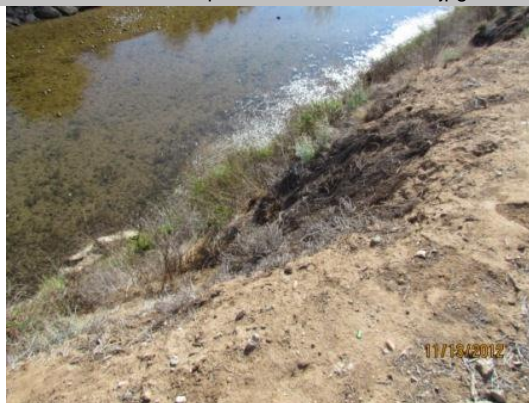
Photo 1 of 1 : pkazi_s_20140415_371.jpg

Erosion was found on the waterside slope of the levee looking downstream.

LM Start	3.81	Rating **	A/W	Issue No.	42
LM End	3.81	Issue Type +	Ma	Location *	WS
Category	Earthen Levee			GPS Latitude/Longitude	
				Start	End
Item	Erosion / Bank Caving			38.019623 °	38.019623 °
				-121.063492 °	-121.063492 °
DWR ID	DWR_NA0017_15_f_2012_42				
Action/Comments					
Schedule repair of erosion site prior to the next inspection.

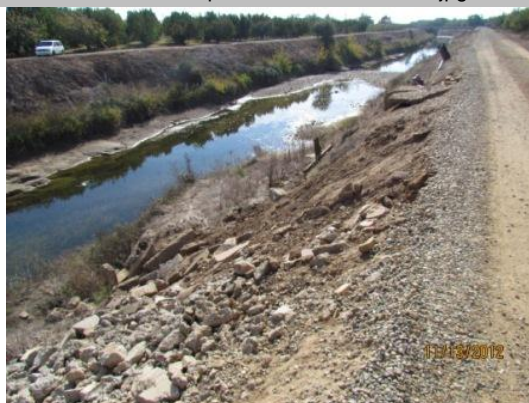
Photo 1 of 2 : pkazi_s_20140415_372.jpg

Slope instability was found on the landside slope of the levee looking downstream.

LM Start	3.86	Rating **	M	Issue No.	43
LM End	3.86	Issue Type +	Ma	Location *	WS
Category	Earthen Levee			GPS Latitude/Longitude	
				Start	End
Item	Slope Stability			38.019119 °	38.019119 °
				-121.064034 °	-121.064034 °
DWR ID	DWR_NA0017_15_f_2012_43				
Action/Comments					
Repair slope instability.

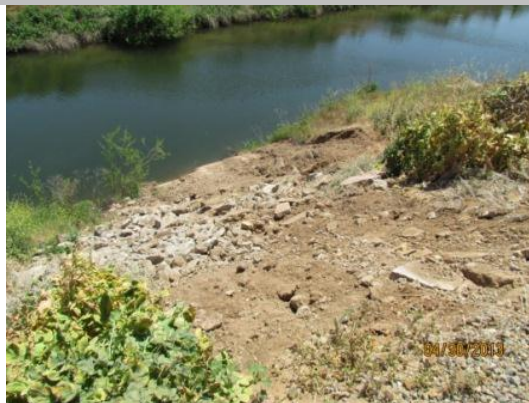
Photo 2 of 2 : pkazi_s_20140415_373.jpg

Updated picture of the slope instability on the waterside slope of the levee looking downstream.

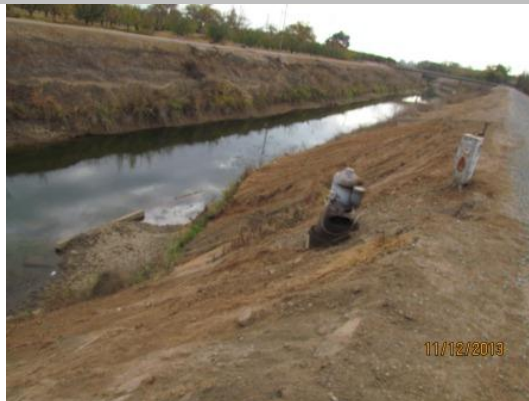
Photo 1 of 4 : pkazi_s_20140415_376.jpg

Updated picture of the slope instability on the waterside slope of the levee looking downstream during fall 2013 inspection.

LM Start	3.97	Rating **	M	Issue No.	44
LM End	3.97	Issue Type +	Ma	Location *	WS
Category	Earthen Levee			GPS Latitude/Longitude	
				Start	End
Item	Slope Stability			38.017945 °	38.017945 °
				-121.065295 °	-121.065295 °
DWR ID	DWR_NA0017_15_f_2012_44				
Action/Comments					
Repair slope instability.

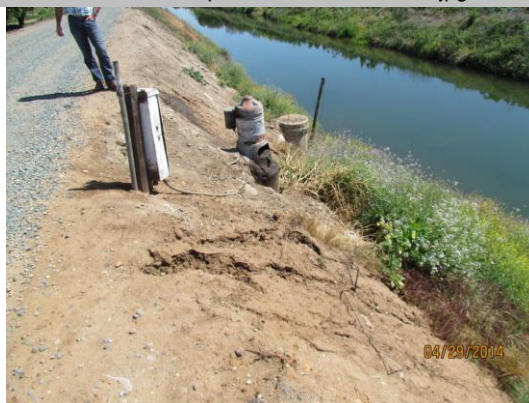
Photo 2 of 4 : pkazi_s_20140505_934.jpg

Updated picture of the slope instability on the waterside slope of the levee looking downstream during spring 2014 inspection.

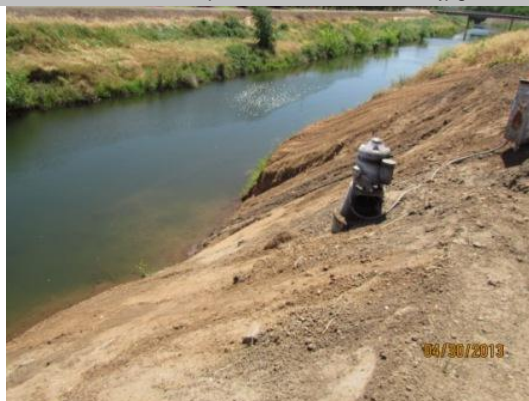
Photo 3 of 4 : pkazi_s_20140415_375.jpg

Updated picture of the slope instability on the waterside slope of the levee looking downstream.

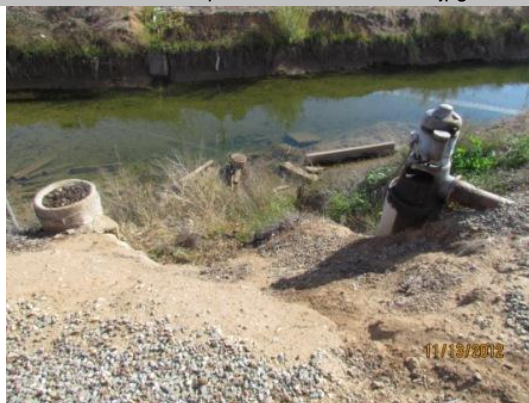
Photo 4 of 4 : pkazi_s_20140415_374.jpg

Slope instability was found on the landside slope of the levee looking downstream.

LM Start	3.97	Rating **	M	Issue No.	44 (cont)	
LM End	3.97	Issue Type +	Ma	Location *	WS	
Category	Earthen Levee			GPS Latitude/Longitude		
				Start		End
Item	Slope Stability			38.017945 °		38.017945 °
				-121.065295 °		-121.065295 °
DWR ID	DWR_NA0017_15_f_2012_44					
Action/Comments						
Repair slope instability.

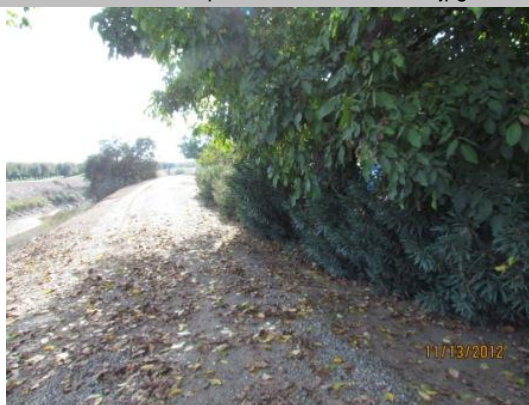
Photo 1 of 1 : pkazi_s_20140415_346.jpg

Landscape was blocking the visibility on the landside of the levee looking downstream.

LM Start	4.13	Rating **	M	Issue No.	16
LM End	4.15	Issue Type +	En	Location *	LS
Category	Earthen Levee			GPS Latitude/Longitude	
				Start	End
Item	Vegetation			38.016209 °	38.015833 °
				-121.067111 °	-121.067185 °
DWR ID	DWR_NA0017_15_s_2012_16				
Action/Comments					
Landscaping

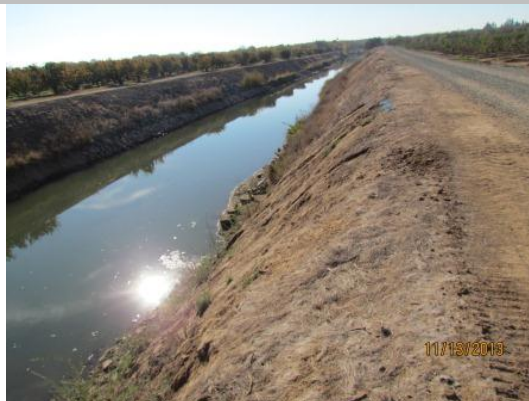
Photo 1 of 1 : pkazi_s_20140415_363.jpg

Slope instability was found on the waterside slope of the levee looking downstream.

LM Start	4.41	Rating **	M	Issue No.	33
LM End	4.41	Issue Type +	Ma	Location *	WS
Category	Earthen Levee			GPS Latitude/Longitude	
				Start	End
Item	Slope Stability			38.012471 °	38.012471 °
				-121.068662 °	-121.068662 °
DWR ID	DWR_NA0017_15_f_2013_33				
Action/Comments					
Repair slope instability.

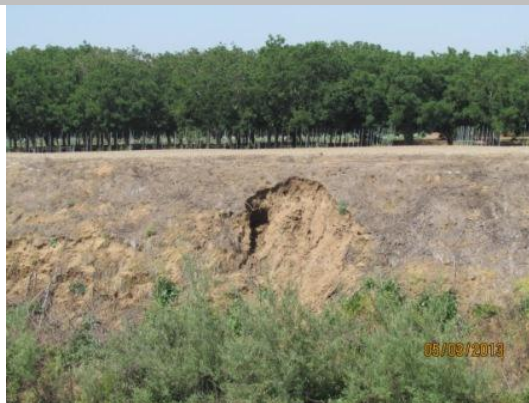
Photo 1 of 1 : pkazi_s_20140415_436.jpg

An animal hole was found on the waterside slope of the levee. The picture was taken from the opposite side of the levee.

LM Start	4.44	Rating **	U	Issue No.	124
LM End	4.44	Issue Type +	Ma	Location *	WS
Category	Earthen Levee			GPS Latitude/Longitude	
				Start	End
Item	Animal Control			38.012910 °	38.012910 °
				-121.067996 °	-121.067996 °
DWR ID	DWR_NA0017_15_s_2013_124				
Action/Comments					
No rodents visible, but rodent burrows visible; need to backfill and compact or grout burrows. Inspector Comments: Picture was taken from the other side of the levee.

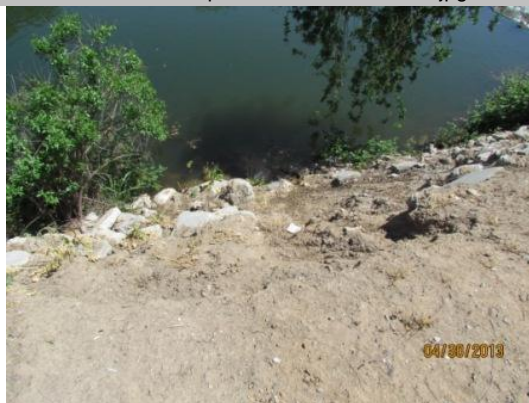
Photo 1 of 3 : pkazi_s_20140415_417.jpg

Updated picture of the slope instability on the waterside slope of the levee looking downstream during spring 2013 inspection.

LM Start	4.73	Rating **	M	Issue No.	96
LM End	4.73	Issue Type +	Ma	Location *	WS
Category	Earthen Levee			GPS Latitude/Longitude	
				Start	End
Item	Erosion / Bank Caving			38.008053 °	38.008053 °
				-121.070141 °	-121.070141 °
DWR ID	DWR_NA0017_15_s_2012_96				
Action/Comments					
Note and monitor erosion site.					
Inspector Comments: LMA has fixed the issue but the riprap has rebar which would can be dangerous during the flood fighting efforts.

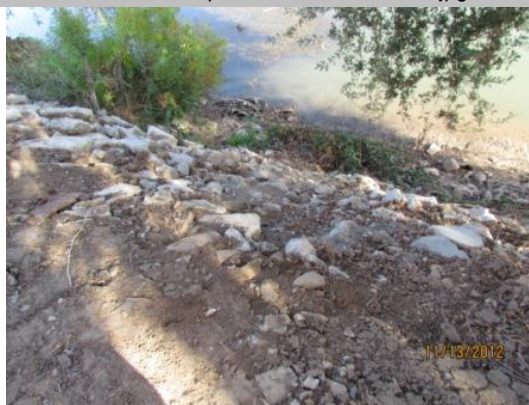
Photo 2 of 3 : pkazi_s_20140415_416.jpg

The LMA has fixed the erosion on the landside slope of the levee but the riprap contains exposed rebar which could be dangerous during a flood fight.

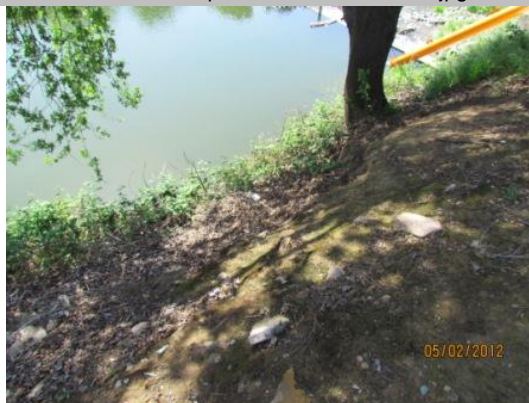
Photo 3 of 3 : pkazi_s_20140415_415.jpg

Erosion was found on the waterside slope of the levee looking downstream.

LM Start	4.73	Rating **	M	Issue No.	96 (cont)
LM End	4.73	Issue Type +	Ma	Location *	WS
Category	Earthen Levee			GPS Latitude/Longitude	
				Start	End
Item	Erosion / Bank Caving			38.008053 °	38.008053 °
				-121.070141 °	-121.070141 °
DWR ID	DWR_NA0017_15_s _ 2012_96				
Action/Comments					
Note and monitor erosion site.

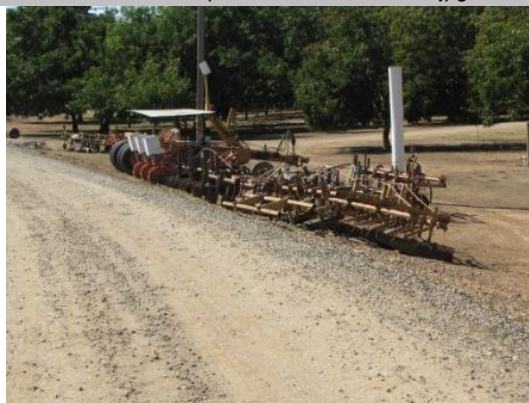
Photo 1 of 1 : pkazi_s_20140415_352.jpg

View of equipment along the landward slope looking downstream.

LM Start	4.96	Rating **	M	Issue No.	20
LM End	4.96	Issue Type +	En	Location *	LS
Category	Earthen Levee			GPS Latitude/Longitude	
				Start	End
Item	Encroachments			38.005302 °	38.005302 °
				-121.071867 °	-121.071867 °
DWR ID	DWR_NA0017_15_s _ 2012_20				
Action/Comments					
Equipment

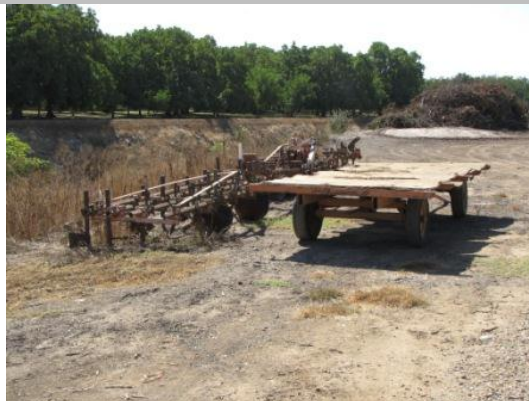
Photo 1 of 1 : pkazi_s_20140415_353.jpg

View of equipment along the waterward side of the levee crown looking downstream.

LM Start	4.96	Rating **	M	Issue No.	21
LM End	4.96	Issue Type +	En	Location *	WS
Category	Earthen Levee			GPS Latitude/Longitude	
				Start	End
Item	Encroachments			38.005300 °	38.005300 °
				-121.071863 °	-121.071863 °
DWR ID	DWR_NA0017_15_s_2012_21				
Action/Comments					
Equipment

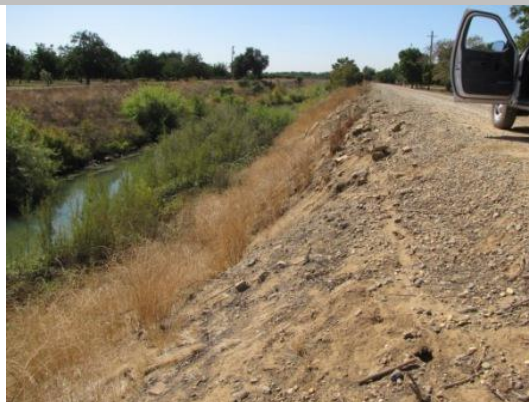
Photo 1 of 1 : pkazi_s_20140415_456.jpg

View of a slip in the waterward levee slope looking downstream.

LM Start	5.14	Rating **	M	Issue No.	1009
LM End	5.14	Issue Type +	Ma	Location *	WS
Category	Earthen Levee			GPS Latitude/Longitude	
				Start	End
Item	Slope Stability			38.003021 °	38.003021 °
				-121.073658 °	-121.073658 °
DWR ID	DWR_NA0017_15_s_2012_1009				
Action/Comments					
Repair slope instability.

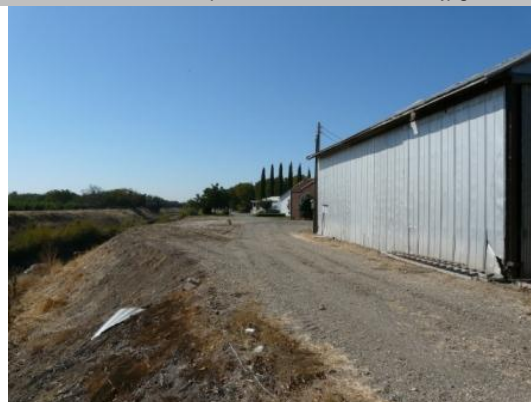
Photo 1 of 1 : pkazi_s_20140415_354.jpg

Building located immediately adjacent to access road approximately from LM 5.38 to 5.45

LM Start	5.38	Rating **	M	Issue No.	24
LM End	5.45	Issue Type +	En	Location *	LS
Category	Earthen Levee			GPS Latitude/Longitude	
				Start	End
Item	Encroachments			38.000308 °	37.999502 °
				-121.076133 °	-121.076835 °
DWR ID	DWR_NA0017_15_s_2012_24				
Action/Comments					
Building

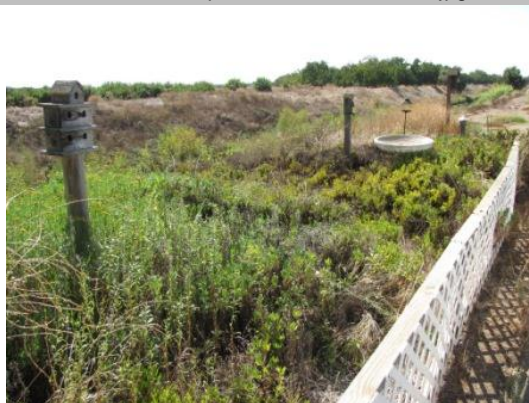
Photo 1 of 1 : pkazi_s_20140415_457.jpg

View of landscaping planted along the waterward side of the access road impacting visibility and the ability to floodfight looking downstream.

LM Start	5.42	Rating **	M	Issue No.	1012
LM End	5.42	Issue Type +	En	Location *	WS
Category	Earthen Levee			GPS Latitude/Longitude	
				Start	End
Item	Vegetation			37.999718 °	37.999718 °
				-121.076665 °	-121.076665 °
DWR ID	DWR_NA0017_15_s_2012_1012				
Action/Comments					
Landscaping

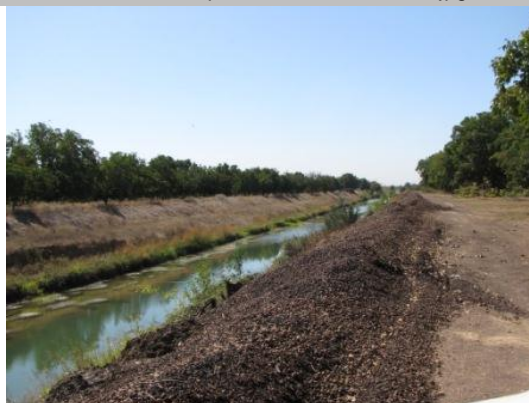
Photo 1 of 2 : pkazi_s_20140415_458.jpg

LM Start	5.60	Rating **	M	Issue No.	1014
LM End	5.65	Issue Type +	En	Location *	WS
Category	Earthen Levee			GPS Latitude/Longitude	
				Start	End
Item	Encroachments			37.997619 °	37.997043 °
				-121.078405 °	-121.078972 °
DWR ID	DWR_NA0017_15_s_2012_1014				
Action/Comments					
Material Inspector Comments: Walnut piles on waterward shoulder.

View of discarded nut shells placed along the waterward slope to be burned looking downstream.

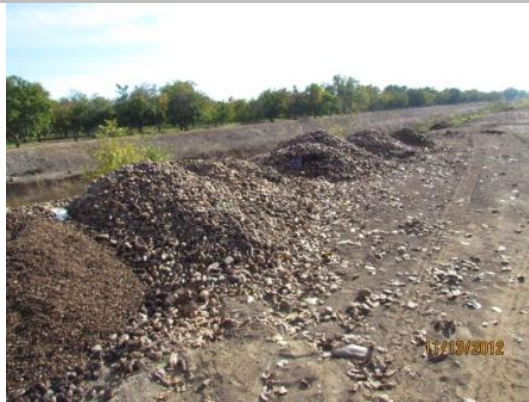
Photo 2 of 2 : pkazi_s_20140415_459.jpg

In addition to the walnut piles, there were rocks and debris were found at the landside shoulder of the levee looking downstream.

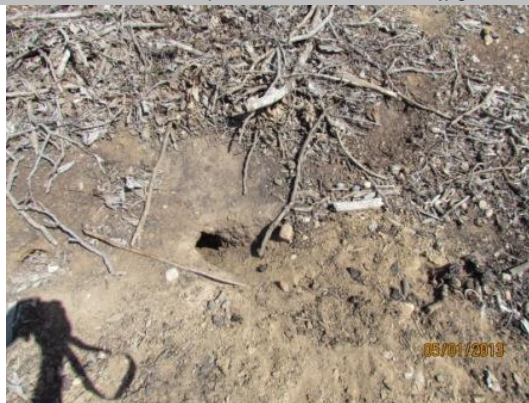
Photo 1 of 1 : pkazi_s_20140415_357.jpg

An animal hole was found on the waterside slope of the levee looking upstream.

LM Start	5.69	Rating **	M	Issue No.	26
LM End	5.69	Issue Type +	Ma	Location *	WS
Category	Earthen Levee			GPS Latitude/Longitude	
				Start	End
Item	Animal Control			37.996601 °	37.996601 °
				-121.079401 °	-121.079401 °
DWR ID	DWR_NA0017_15_s_2013_26				
Action/Comments					
No rodents visible, but rodent burrows visible; need to backfill and

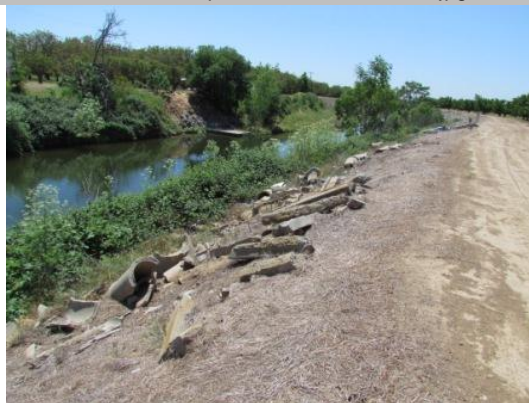
Photo 1 of 2 : pkazi_s_20140415_355.jpg

Broken concrete pipes and other debris were found on the waterside of the levee. The picture was taken from the crown looking downstream.

LM Start	5.76	Rating **	M	Issue No.	25
LM End	5.86	Issue Type +	En	Location *	WS
Category	Earthen Levee			GPS Latitude/Longitude	
				Start	End
Item	Encroachments			37.995733 °	37.994670 °
				-121.080102 °	-121.081207 °
DWR ID	DWR_NA0017_15_s_2012_25				
Action/Comments					
Debris

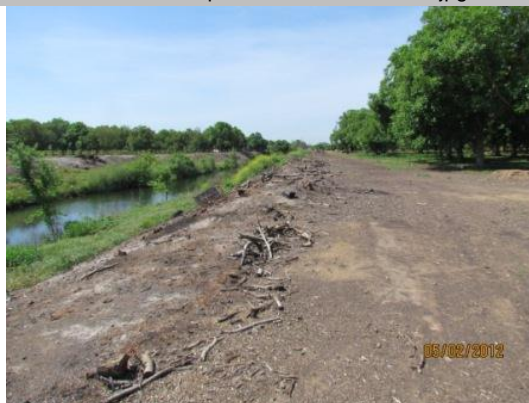
Photo 2 of 2 : pkazi_s_20140415_356.jpg

Debris were still on the waterside of the levee looking downstream. This picture was taken during Spring 2012 inspection.

LM Start	5.76	Rating **	M	Issue No.	25 (cont)
LM End	5.86	Issue Type +	En	Location *	WS
Category	Earthen Levee			GPS Latitude/Longitude	
				Start	End
Item	Encroachments			37.995733 °	37.994670 °
				-121.080102 °	-121.081207 °
DWR ID	DWR_NA0017_15_s _ 2012_25				
Action/Comments					
Debris

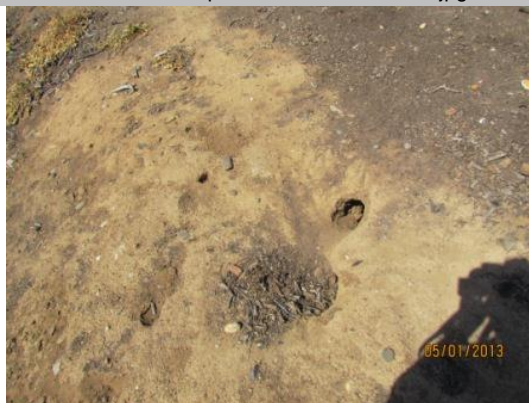
Photo 1 of 2 : pkazi_s_20140415_360.jpg

Animal holes were found on the waterside slope of the levee looking downstream.

LM Start	5.77	Rating **	M	Issue No.	30
LM End	5.77	Issue Type +	Ma	Location *	WS
Category	Earthen Levee			GPS Latitude/Longitude	
				Start	End
Item	Animal Control			37.995679 °	37.995679 °
				-121.080267 °	-121.080267 °
DWR ID	DWR_NA0017_15_s _ 2013_30				
Action/Comments					
No rodents visible, but rodent burrows visible; need to backfill and compact or grout burrows.

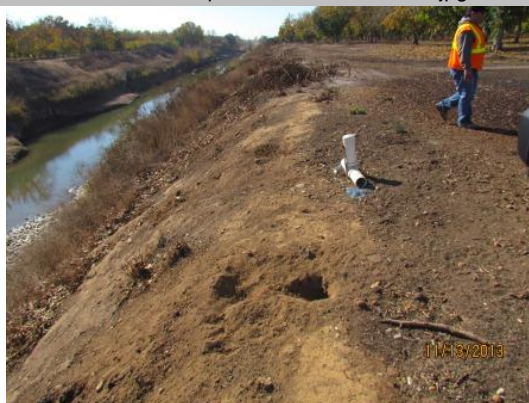
Photo 2 of 2 : pkazi_s_20140415_361.jpg

Updated picture of the animal holes on the waterside of the levee looking downstream.

LM Start	5.77	Rating **	M	Issue No.	30 (cont)
LM End	5.77	Issue Type +	Ma	Location *	WS
Category	Earthen Levee			GPS Latitude/Longitude	
				Start	End
Item	Animal Control			37.995679 °	37.995679 °
				-121.080267 °	-121.080267 °
DWR ID	DWR_NA0017_15_s_2013_30				
Action/Comments					
No rodents visible, but rodent burrows visible; need to backfill and compact or grout burrows.

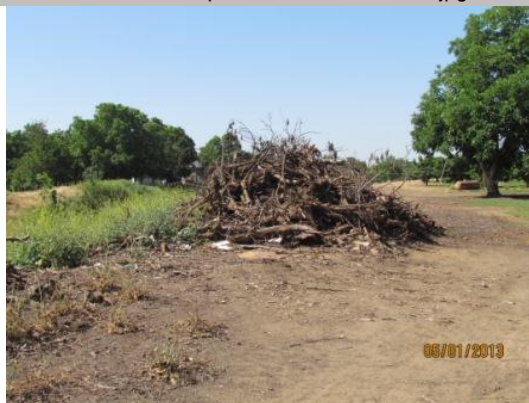
Photo 1 of 1 : pkazi_s_20140415_362.jpg

LM Start	5.86	Rating **	M	Issue No.	31
LM End	5.86	Issue Type +	En	Location *	WS
Category	Earthen Levee			GPS Latitude/Longitude	
				Start	End
Item	Encroachments			37.994669 °	37.994669 °
				-121.081245 °	-121.081245 °
DWR ID	DWR_NA0017_15_s_2013_31				
Action/Comments					
Prunings

Prunings were found on the waterside slope of the levee looking downstream.

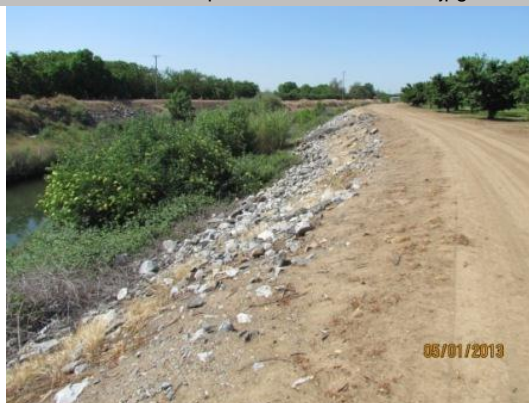
Photo 1 of 1 : pkazi_s_20140415_406.jpg

LM Start	5.95	Rating **	M	Issue No.	84
LM End	6.05	Issue Type +	En	Location *	WS
Category	Earthen Levee			GPS Latitude/Longitude	
				Start	End
Item	Encroachments			37.993554 °	37.992476 °
				-121.082192 °	-121.083241 °
DWR ID	DWR_NA0017_15_s_2012_84				
Action/Comments					
Material

Materials were found on the waterside slope of the levee looking downstream.

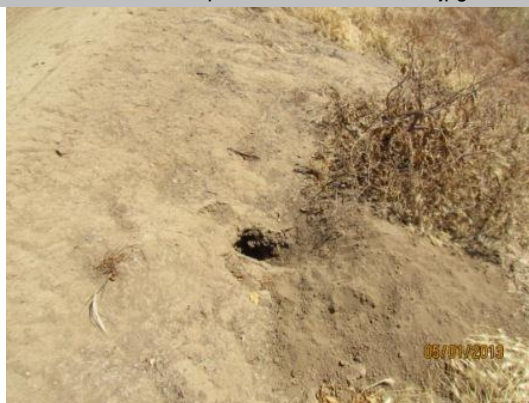
Photo 1 of 1 : pkazi_s_20140415_370.jpg

An animal hole was found on the waterside slope of the levee looking upstream.

LM Start	6.12	Rating **	M	Issue No.	41
LM End	6.12	Issue Type +	Ma	Location *	WS
Category	Earthen Levee			GPS Latitude/Longitude	
				Start	End
Item	Animal Control			37.991648 °	37.991648 °
				-121.083924 °	-121.083924 °
DWR ID	DWR_NA0017_15_s_2013_41				
Action/Comments					
No rodents visible, but rodent burrows visible; need to backfill and compact or grout burrows.

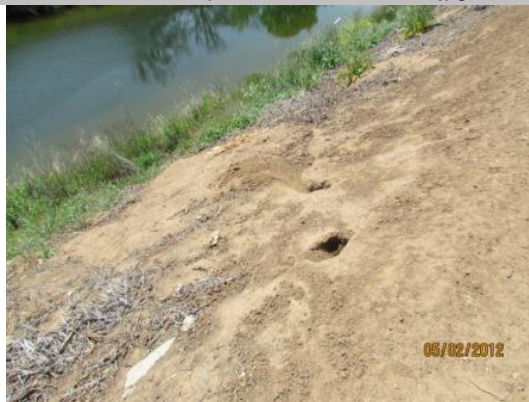
Photo 1 of 1 : pkazi_s_20140415_430.jpg

Animal holes were found on the waterside of the levee looking downstream.

LM Start	6.20	Rating **	M	Issue No.	116
LM End	6.20	Issue Type +	Ma	Location *	WS
Category	Earthen Levee			GPS Latitude/Longitude	
				Start	End
Item	Animal Control			37.990773 °	37.990773 °
				-121.084706 °	-121.084706 °
DWR ID	DWR_NA0017_15_s_2012_116				
Action/Comments					
No rodents visible, but rodent burrows visible; need to backfill and compact or grout burrows.

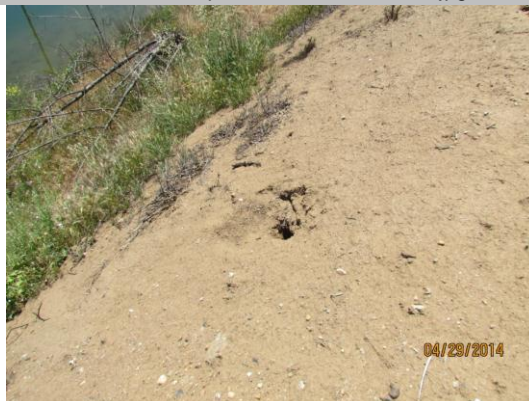
Photo 1 of 1 : pkazi_s_20140505_936.jpg

A rodent hole was found on the waterside shoulder of the levee looking downstream.

LM Start	6.30	Rating **	M	Issue No.	75
LM End	6.30	Issue Type +	Ma	Location *	WS
Category	Earthen Levee			GPS Latitude/Longitude	
				Start	End
Item	Animal Control			37.989630 °	37.989630 °
				-121.085754 °	-121.085754 °
DWR ID	DWR_NA0017_15_s_2014_75				
Action/Comments					
No rodents visible, but rodent burrows visible; need to backfill and compact or grout burrows.

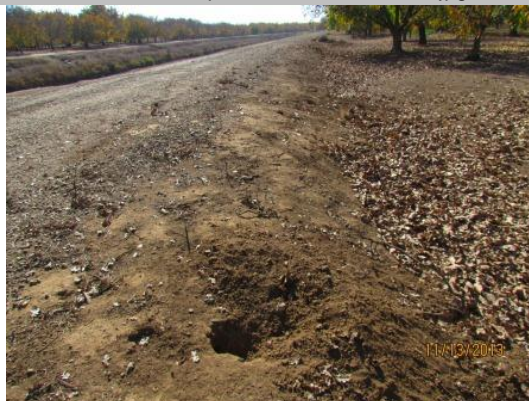
Photo 1 of 1 : pkazi_s_20140415_393.jpg

Rodent holes were found on the landside of the levee looking downstream.

LM Start	6.57	Rating **	M	Issue No.	67
LM End	6.57	Issue Type +	Ma	Location *	LS
Category	Earthen Levee			GPS Latitude/Longitude	
				Start	End
Item	Animal Control			37.986503 °	37.986503 °
				-121.088477 °	-121.088477 °
DWR ID	DWR_NA0017_15_f_2013_67				
Action/Comments					
No rodents visible, but rodent burrows visible; need to backfill and compact or grout burrows.

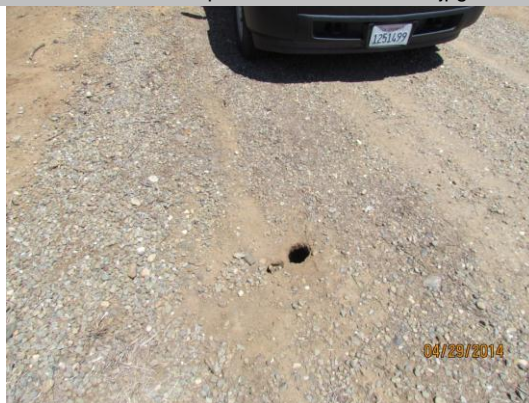
Photo 1 of 1 : pkazi_s_20140505_937.jpg

A rodent hole was found on the crown of the levee looking upstream.

LM Start	6.57	Rating **	M	Issue No.	81
LM End	6.57	Issue Type +	Ma	Location *	CR
Category	Earthen Levee			GPS Latitude/Longitude	
				Start	End
Item	Animal Control			37.986522 °	37.986522 °
				-121.088510 °	-121.088510 °
DWR ID	DWR_NA0017_15_s_2014_81				
Action/Comments					
No rodents visible, but rodent burrows visible; need to backfill and compact or grout burrows.

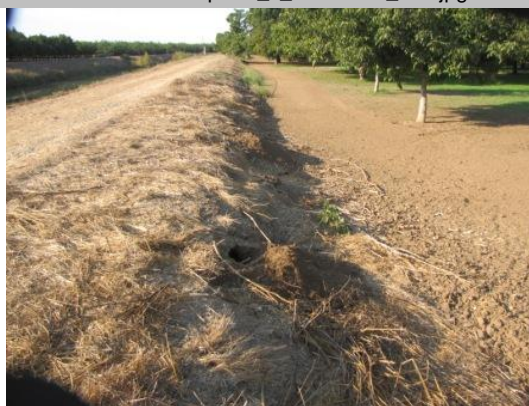
Photo 1 of 1 : pkazi_s_20140415_410.jpg

View of rodent activity in the landward slope looking downstream.

LM Start	6.61	Rating **	M	Issue No.	90
LM End	6.61	Issue Type +	Ma	Location *	LS
Category	Earthen Levee			GPS Latitude/Longitude	
				Start	End
Item	Animal Control			37.986018 °	37.986018 °
				-121.088877 °	-121.088877 °
DWR ID	DWR_NA0017_15_s_2012_90				
Action/Comments					
Exterminate rodents and backfill and compact or grout burrows.

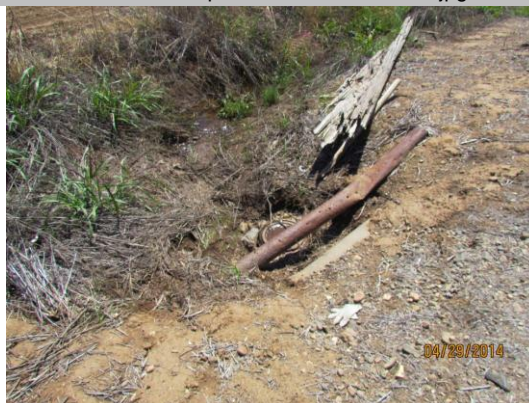
Photo 1 of 1 : pkazi_s_20140505_938.jpg

LM Start	6.72	Rating **	M	Issue No.	82
LM End	6.72	Issue Type +	En	Location *	WS
Category	Earthen Levee			GPS Latitude/Longitude	
				Start	End
Item	Encroachments			37.984696 °	37.984696 °
				-121.090054 °	-121.090054 °
DWR ID	DWR_NA0017_15_s_2014_82				
Action/Comments					
Pipe

An abandon pipe was found on the waterside slope of the levee looking downstream.

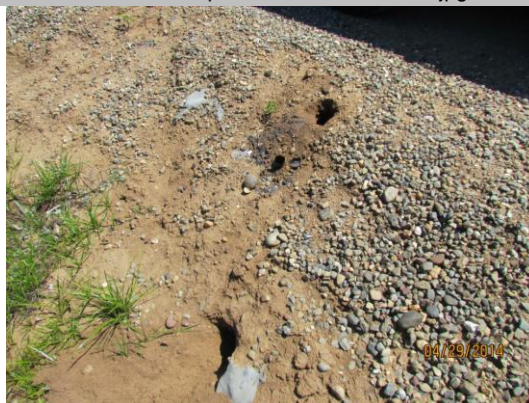
Photo 1 of 1 : pkazi_s_20140505_939.jpg

Rodent holes were found on the landside of the levee looking upstream.

LM Start	6.79	Rating **	M	Issue No.	105
LM End	6.79	Issue Type +	Ma	Location *	LS
Category	Earthen Levee			GPS Latitude/Longitude	
				Start	End
Item	Animal Control			37.984100 °	37.984100 °
				-121.090772 °	-121.090772 °
DWR ID	DWR_NA0017_15_s_2014_105				
Action/Comments					
No rodents visible, but rodent burrows visible; need to backfill and compact or grout burrows.

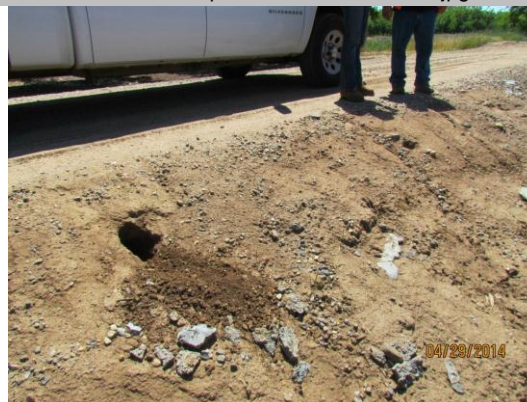
Photo 1 of 1 : pkazi_s_20140505_940.jpg

A rodent hole was found on the landside shoulder of the levee looking downstream.

LM Start	6.86	Rating **	M	Issue No.	113
LM End	6.86	Issue Type +	Ma	Location *	LS
Category	Earthen Levee			GPS Latitude/Longitude	
				Start	End
Item	Animal Control			37.983511 °	37.983511 °
				-121.091645 °	-121.091645 °
DWR ID	DWR_NA0017_15_s_2014_113				
Action/Comments					
No rodents visible, but rodent burrows visible; need to backfill and compact or grout burrows.

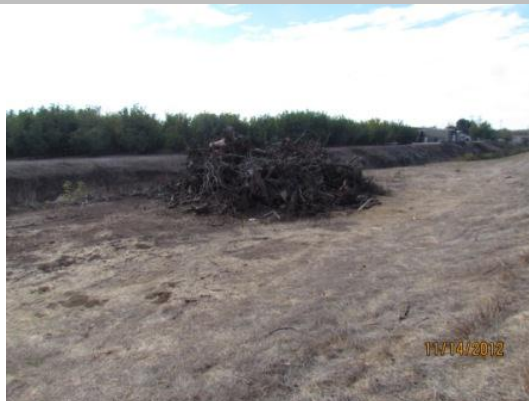
Photo 1 of 1 : pkazi_s_20140415_411.jpg

LM Start	6.89	Rating **	M	Issue No.	91
LM End	6.89	Issue Type +	En	Location *	WS
Category	Earthen Levee			GPS Latitude/Longitude	
				Start	End
Item	Encroachments			37.983109 °	37.983109 °
				-121.092251 °	-121.092251 °
DWR ID	DWR_NA0017_15_s_2012_91				
Action/Comments					
Prunings

Prunings were found on the waterside shoulder of the levee looking downstream.

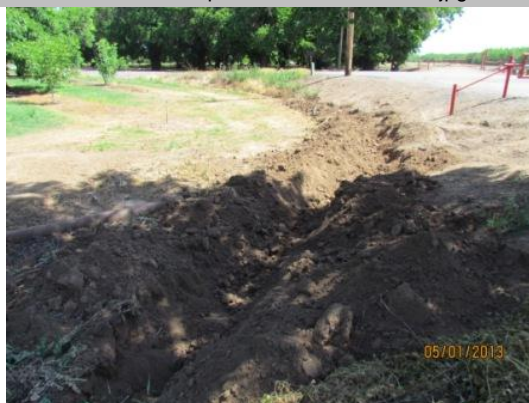
Photo 1 of 1 : pkazi_s_20140415_380.jpg

LM Start	7.09	Rating **	M	Issue No.	51
LM End	7.09	Issue Type +	En	Location *	LS
Category	Earthen Levee			GPS Latitude/Longitude	
				Start	End
Item	Encroachments			37.981517 °	37.981517 °
				-121.095061 °	-121.095061 °
DWR ID	DWR_NA0017_15_s_2013_51				
Action/Comments					
Ditch

An agricultural ditch was found on the landside toe of the levee looking upstream.

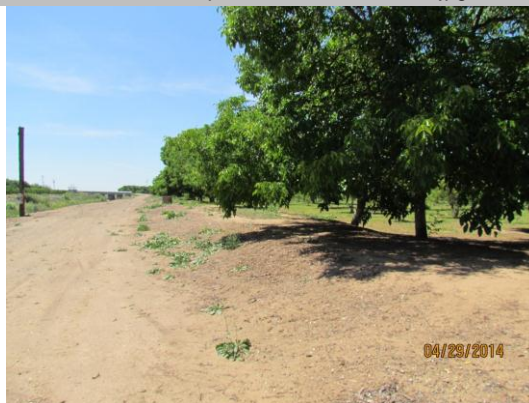
Photo 1 of 1 : pkazi_s_20140505_941.jpg

Tree limbs were obstructing the visibility of the crown of the levee looking downstream.

LM Start	7.11	Rating **	M	Issue No.	115
LM End	7.35	Issue Type +	Ma	Location *	LS
Category	Earthen Levee			GPS Latitude/Longitude	
				Start	End
Item	Trim / Thin Trees			37.981387 °	37.979749 °
				-121.095370 °	-121.099178 °
DWR ID	DWR_NA0017_15_s_2014_115				
Action/Comments					
Trim trees to at least five feet above ground level.

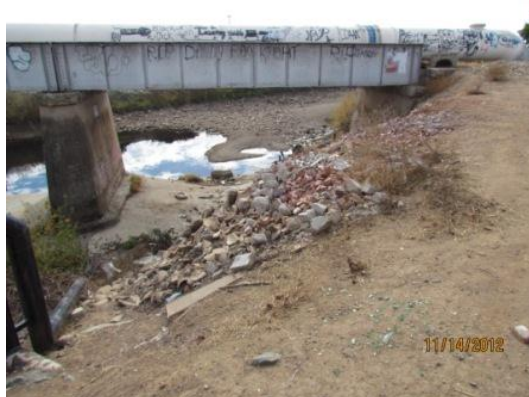
Photo 1 of 1 : pkazi_s_20140415_421.jpg

LM Start	7.36	Rating **	M	Issue No.	102
LM End	7.36	Issue Type +	Ma	Location *	WS
Category	Earthen Levee			GPS Latitude/Longitude	
				Start	End
Item	Encroachments			37.979612 °	37.979612 °
				-121.099390 °	-121.099390 °
DWR ID	DWR_NA0017_15_s_2012_102				
Action/Comments					
Debris

Debris was found on the waterside slope of the levee looking downstream.

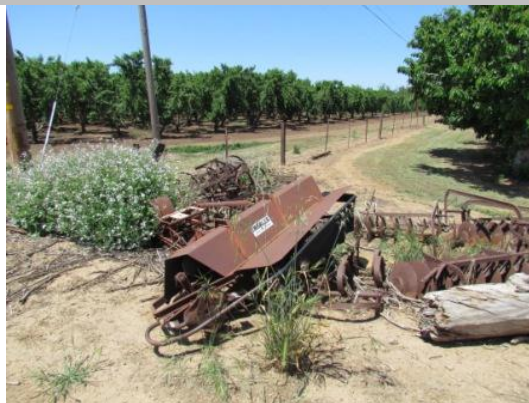
Photo 1 of 1 : pkazi_s_20140415_440.jpg

LM Start	7.98	Rating **	A/W	Issue No.	144
LM End	7.98	Issue Type +	En	Location *	LS
Category	Earthen Levee			GPS Latitude/Longitude	
				Start	End
Item	Encroachments			37.974829 °	37.974829 °
				-121.108405 °	-121.108405 °
DWR ID	DWR_NA0017_15_s_2012_144				
Action/Comments					
Equipment

Equipment was left by the farmers on the landside of the levee. The picture was taken from crown looking toward the landside of the levee.

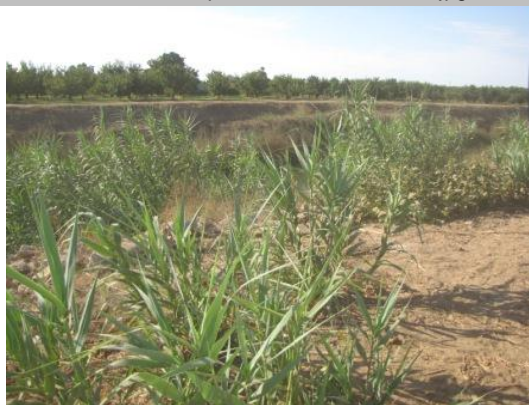
Photo 1 of 2 : pkazi_s_20140415_422.jpg

View of arrundo on the waterward shoulder and slope blocking visibility looking downstream.

LM Start	8.06	Rating **	M	Issue No.	104
LM End	8.06	Issue Type +	Ma	Location *	WS
Category	Earthen Levee			GPS Latitude/Longitude	
				Start	End
Item	Vegetation			37.974304 °	37.974304 °
				-121.109625 °	-121.109625 °
DWR ID	DWR_NA0017_15_s_2012_104				
Action/Comments					
Remove the wild growth other than native grasses from the levee slopes.

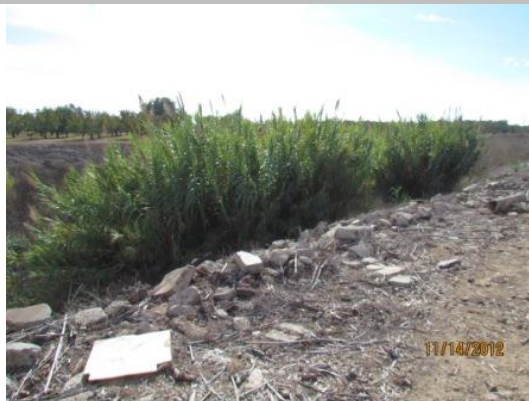
Photo 2 of 2 : pkazi_s_20140415_423.jpg

Updated picture of the Arundo on the waterside slope of the levee looking downstream.

LM Start	8.06	Rating **	M	Issue No.	104 (cont)
LM End	8.06	Issue Type +	Ma	Location *	WS
Category	Earthen Levee			GPS Latitude/Longitude	
				Start	End
Item	Vegetation			37.974304 °	37.974304 °
				-121.109625 °	-121.109625 °
DWR ID	DWR_NA0017_15_s_2012_104				
Action/Comments					
Remove the wild growth other than native grasses from the levee slopes.

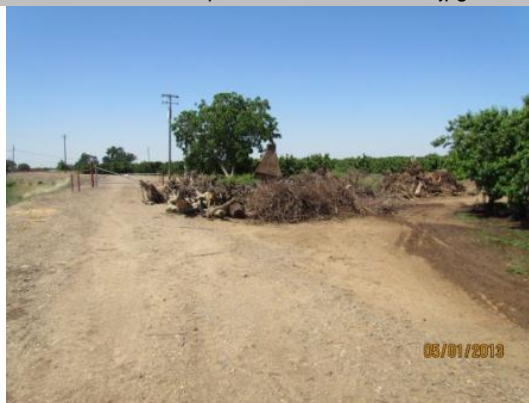
Photo 1 of 1 : pkazi_s_20140415_364.jpg

LM Start	8.24	Rating **	M	Issue No.	34
LM End	8.24	Issue Type +	En	Location *	LS
Category	Earthen Levee			GPS Latitude/Longitude	
				Start	End
Item	Encroachments			37.972823 °	37.972823 °
				-121.112400 °	-121.112400 °
DWR ID	DWR_NA0017_15_s_2012_34				
Action/Comments					
Prunings

Prunings were found on the landside of the levee looking downstream.

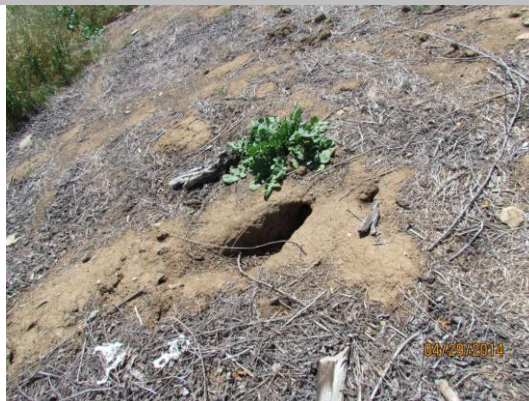
Photo 1 of 1 : pkazi_s_20140505_942.jpg

A rodent hole was found on the waterside of the levee looking downstream.

LM Start	8.28	Rating **	M	Issue No.	122
LM End	8.28	Issue Type +	Ma	Location *	WS
Category	Earthen Levee			GPS Latitude/Longitude	
				Start	End
Item	Animal Control			37.972590 °	37.972590 °
				-121.112938 °	-121.112938 °
DWR ID	DWR_NA0017_15_s_2014_122				
Action/Comments					
No rodents visible, but rodent burrows visible; need to backfill and compact or grout burrows.

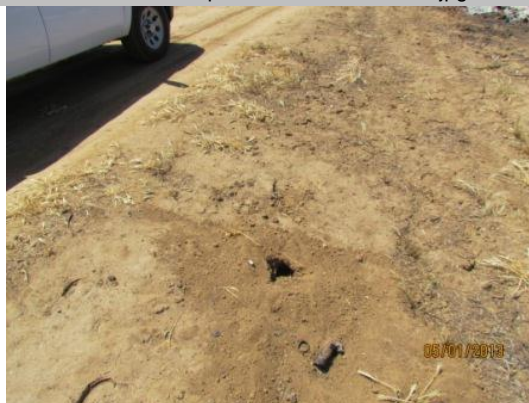
Photo 1 of 1 : pkazi_s_20140415_387.jpg

An animal hole was found on the landside slope of the levee looking downstream.

LM Start	8.49	Rating **	M	Issue No.	62
LM End	8.49	Issue Type +	Ma	Location *	LS
Category	Earthen Levee			GPS Latitude/Longitude	
				Start	End
Item	Animal Control			37.970147 °	37.970147 °
				-121.114849 °	-121.114849 °
DWR ID	DWR_NA0017_15_s_2013_62				
Action/Comments					
No rodents visible, but rodent burrows visible; need to backfill and compact or grout burrows.

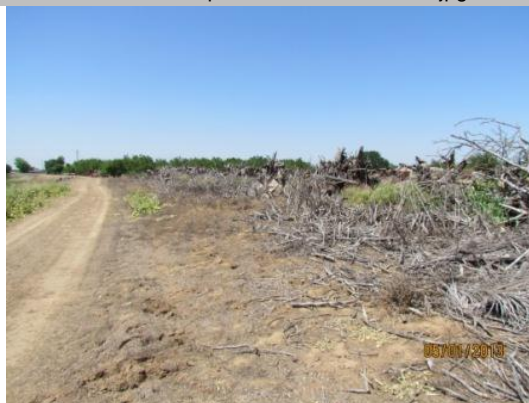
Photo 1 of 1 : pkazi_s_20140415_388.jpg

LM Start	8.58	Rating **	M	Issue No.	63
LM End	8.58	Issue Type +	En	Location *	LS
Category	Earthen Levee			GPS Latitude/Longitude	
				Start	End
Item	Encroachments			37.969813 °	37.969813 °
				-121.116192 °	-121.116192 °
DWR ID	DWR_NA0017_15_s_2013_63				
Action/Comments					
Prunings

Prunings were found on the landside of the levee looking downstream.

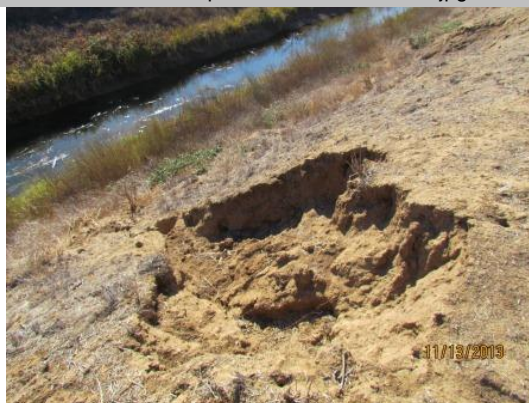
Photo 1 of 3 : pkazi_s_20140415_390.jpg

Updated picture of the slope instability on the waterside of the levee looking downstream during fall 2013 inspection.

LM Start	8.61	Rating **	M	Issue No.	65
LM End	8.61	Issue Type +	Ma	Location *	WS
Category	Earthen Levee			GPS Latitude/Longitude	
				Start	End
Item	Slope Stability			37.969748 °	37.969748 °
				-121.116767 °	-121.116767 °
DWR ID	DWR_NA0017_15_s_2013_65				
Action/Comments					
Repair slope instability.

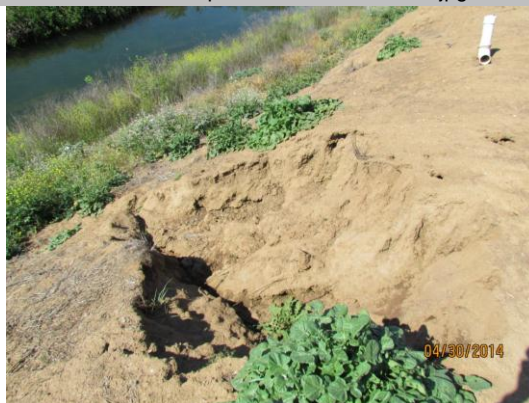
Photo 2 of 3 : pkazi_s_20140505_945.jpg

Updated picture of the slope instability on the waterside of the levee looking downstream during spring 2014 inspection.

LM Start	8.61	Rating **	M	Issue No.	65 (cont)	
LM End	8.61	Issue Type +	Ma	Location *	WS	
Category	Earthen Levee			GPS Latitude/Longitude		
				Start		End
Item	Slope Stability			37.969748 °	37.969748 °	
				-121.116767 °	-121.116767 °	
DWR ID	DWR_NA0017_15_s_2013_65					
Action/Comments						
Repair slope instability.

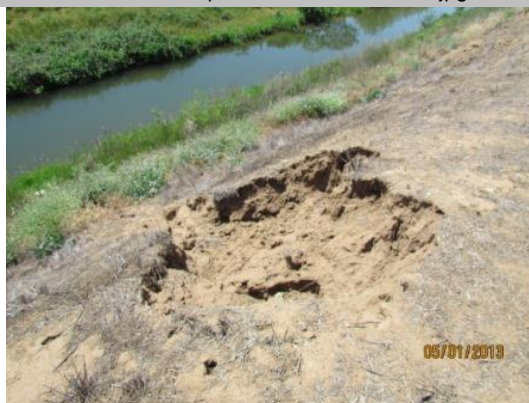
Photo 3 of 3 : pkazi_s_20140415_389.jpg

A slope instability was found on the waterside slope of the levee looking downstream.

LM Start	8.61	Rating **	M	Issue No.	65 (cont)
LM End	8.61	Issue Type +	Ma	Location *	WS

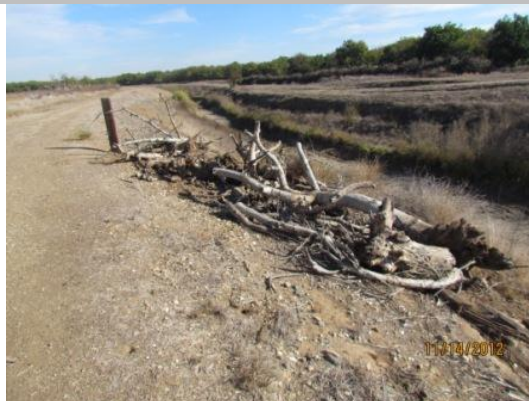
Photo 1 of 1 : pkazi_s_20140415_453.jpg

LM Start	8.66	Rating **	M	Issue No.	982
LM End	8.66	Issue Type +	En	Location *	WS
Category	Earthen Levee			GPS Latitude/Longitude	
				Start	End
Item	Encroachments			37.969611 °	37.969611 °
				-121.117650 °	-121.117650 °
DWR ID	DWR_NA0017_15_s _ 2012_982				
Action/Comments					
Prunings					
Inspector Comments: Burn pile has been burned but new material has been placed.

Prunings were found on the waterside slope of the levee looking upstream.
